# DETERMINATION OF GRAIN SIZE AND RESISTANCE TO CORROSION OF STAINLESS STEEL WELDED PIPES

Pavel Hudeček<sup>1</sup>, Petr Dostál<sup>1</sup>

HUDEČEK PAVEL, DOSTÁL PETR. 2017. Determination of Grain Size and Resistance to Corrosion of Stainless Steel Welded Pipes. *Acta Universitatis Agriculturae et Silviculturae Mendelianae Brunensis*, 65(1): 0025–0033.

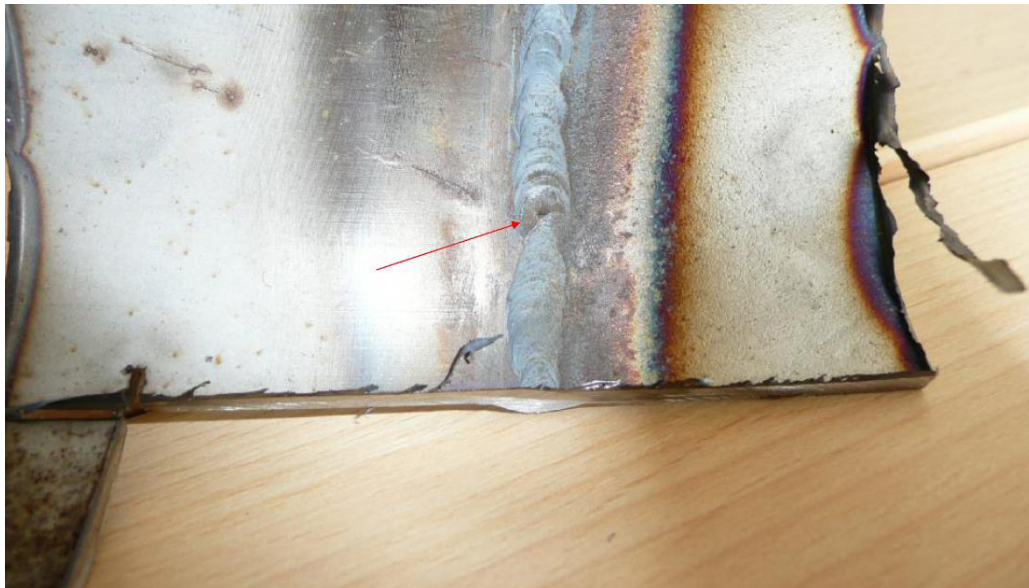
1: Leaker or segregation in root of weld

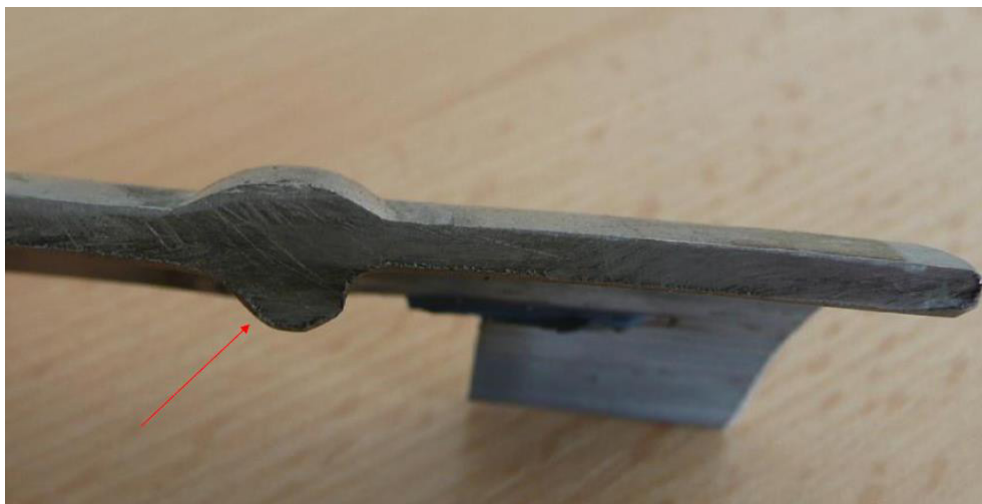
2: Internal protrusion in root of weld

All of the tested samples were investigated and tested of determination grain size and resistance to corrosion. According of testing and analysing the microstructures ssamples and those joint metals are not affected or damaged by an adhered particle of slag on the joint surface. The samples 1-J3 and 1-J5 are damaged along the grain boundary intercrystalline corrosion. The sample 1-elbow the surface was not detected and joint metal is not affected or damaged by slag inclusion. Internal protrusion in root of weld is still in the limit according of standards and strength is no touched.

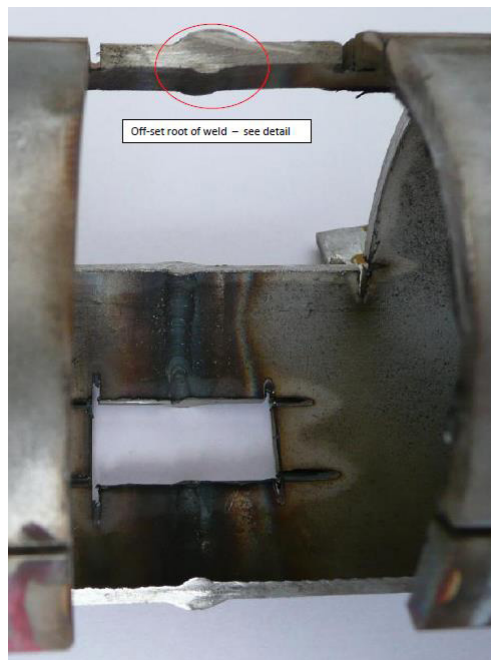
3: Off-set root of weld

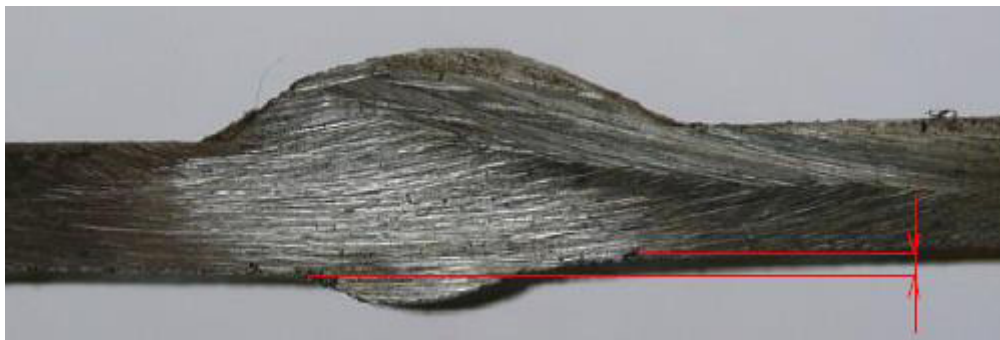
4: Detail Off-set root of weld

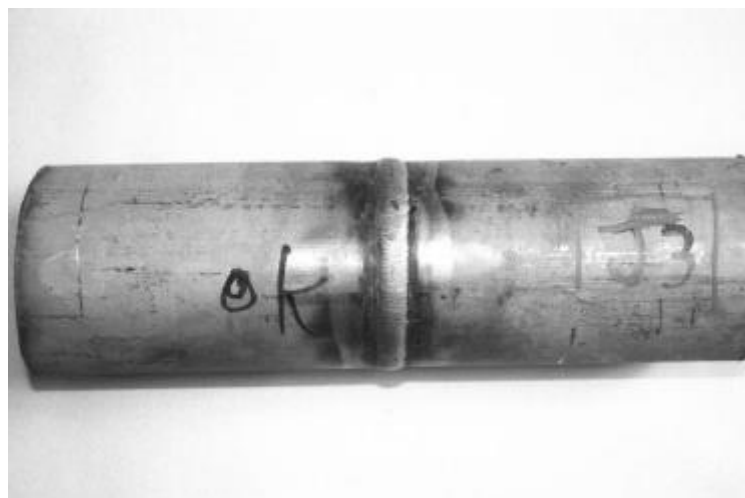
5: Tube sample J3

The tube with a joint indicated as J3, J5 and elbow, see Fig. 5 and 6. The sample of tube was handed over for analysis. On the weld joint and vicinity

On this sample, i.e. the cut through the zone from Fig. 5 an adhered particle of slag was indicated on the joint surface. It is obvious in the Fig. 10, Fig. 11 and 13 there are parts of heat affected joint zones. Fig. 6 the damage of tube surface along the grain boundary is visible – intercrystalline corrosion which reaches the depth of 0.03 mm. The width of these zones is 2.0 mm on the left (reaches 0.3 mm to the joint) and 1.8 mm on the right side. The damage of surface TOO on the left side and the damage of the joint part in the etched specimen is in the Fig. 24.

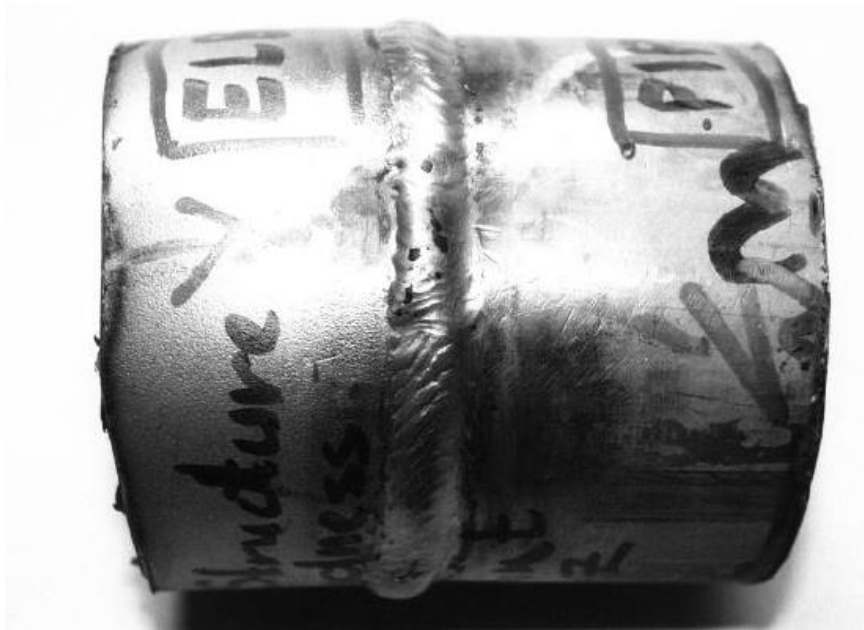
7: Elbow sample

The sample, the cut through zone Fig. 7 no damage of surface TOO was detected. The joint microstructure in this zone is in Fig. 23–28. The joint microstructure in this zone is in Fig. 17, 20 and 23. The base material has an austenitic structure with lines of  $\delta$ -ferrite, grain size  $G_{max} = 3$ , in the heat affected zone  $G_{max} = 4$ . The structure of weld joint is austenitic with  $\delta$ -ferrite. In the joint a slag inclusion of 0,9 mm was found out Fig. 28.

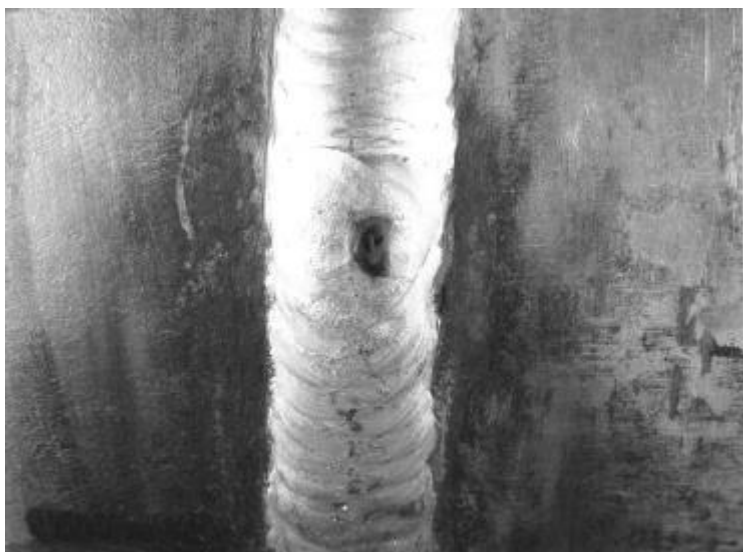
were found deficiencies of surface, black spots (see Fig. 5, 6, 7 and 8) and plugged surface near weld joint (Fig. 9).

8: Deficiencies of surface and black spot sample 1 - JR3

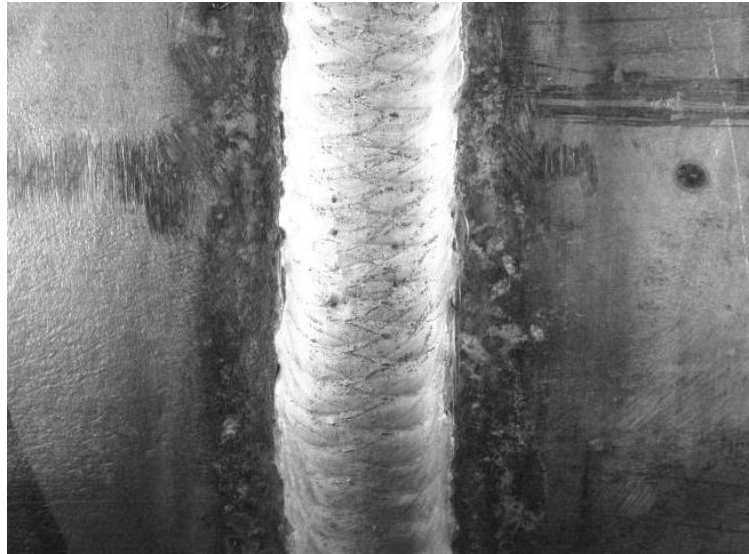
9: *Plugged surface near weld joint*

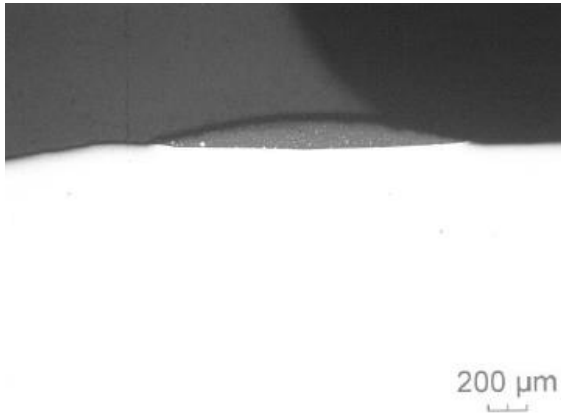
10: *Sample 1 50:1 not etched*

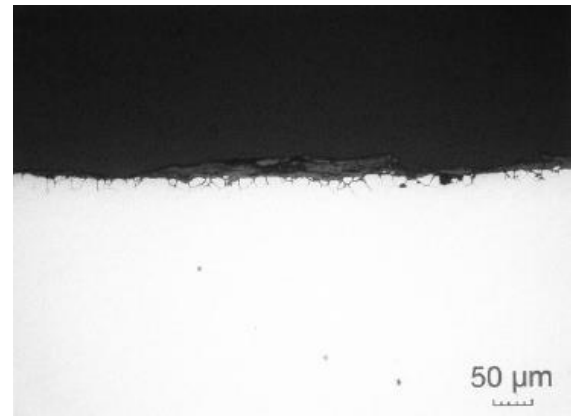
11: *Sample 1-J3 200:1 HAZ on the left - not etched*

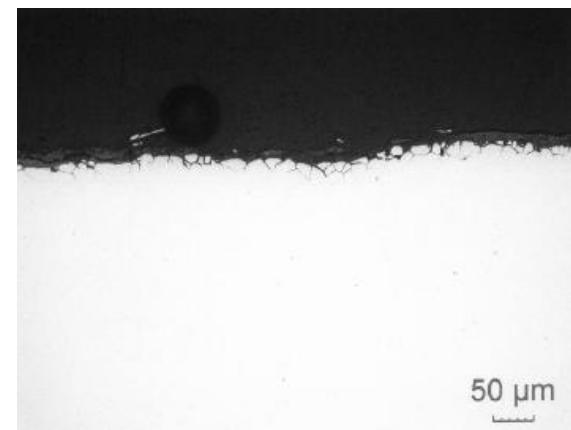
13: *Sample 1-J3 200:1 HAZ on the right - not etched*

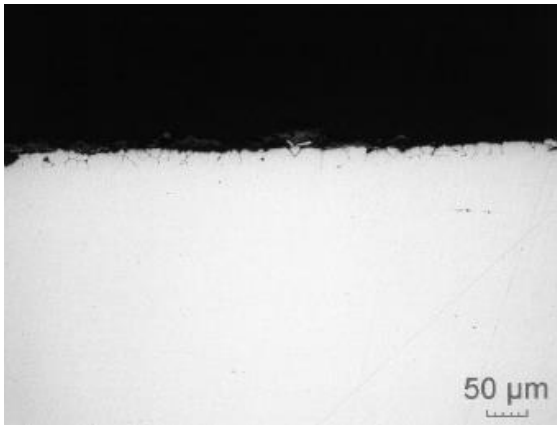
14: Sample 1-J5 200:1 HAZ on the right - not etched

zones is 2.0 mm (front end from the joint toe in the distance of 1,2 mm) on the left and 2,8 mm (front end from the joint toe in the distance of 1,8 mm). The damage of surface in the heat effected joint zone in the etched state is in the Fig. 25. The joint microstructure in this zone is in Fig. 14, 19 and 22. The base material has an austenitic structure with lines of  $\delta$ -ferrite, grain size  $G = 6-7$ , in the heat affected zone  $G_{max} = 4$ . The structure of weld joint is austenitic with  $\delta$ -ferrite.

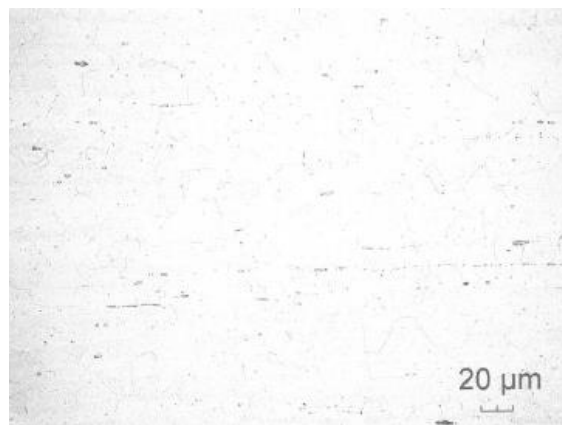
15: Sample 1-J3 400:1 Base material HNO<sub>3</sub>, HCl

The joint microstructure in this zone is in Fig. 15, 18 and 21. The base material has an austenitic structure with lines of  $\delta$ -ferrite, grain size  $G = 6-7$ , in the heat affected zone  $G_{max} = 4$ . The structure of weld joint is austenitic with  $\delta$ -ferrite.

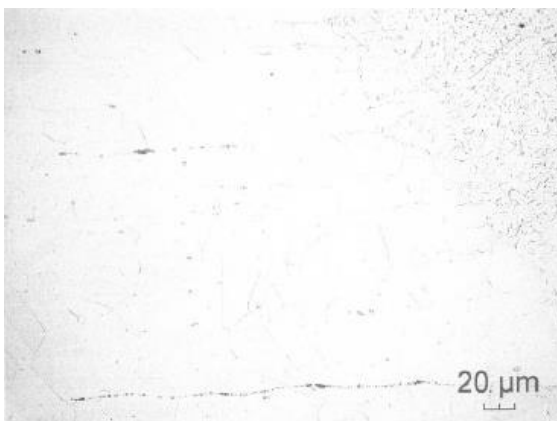
18: Sample 1-J3 400:1 Base material HAZ HNO<sub>3</sub>, HCl

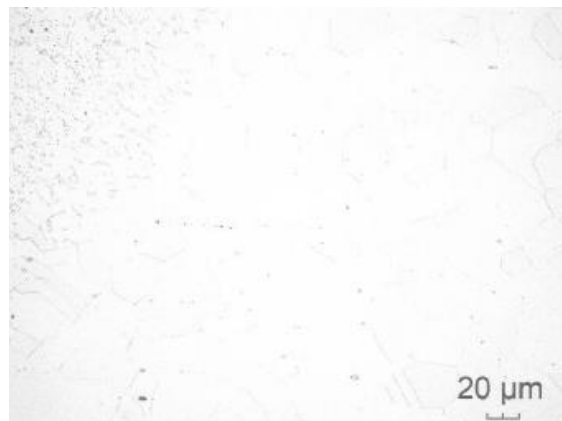
19: Sample 1-J5 400:1 Base material HAZ HNO<sub>3</sub>, HCl
