WATER CONSTRUCTIONS IN COUNTRYSIDE – CASE STUDY OF LAND USE ON THE RIVER SVRATKA IN THE VILLAGE UJČOV (MORAVIA)

Key words: weir, small hydropower plants, Vír dam, fish ladder, the Czech Republic

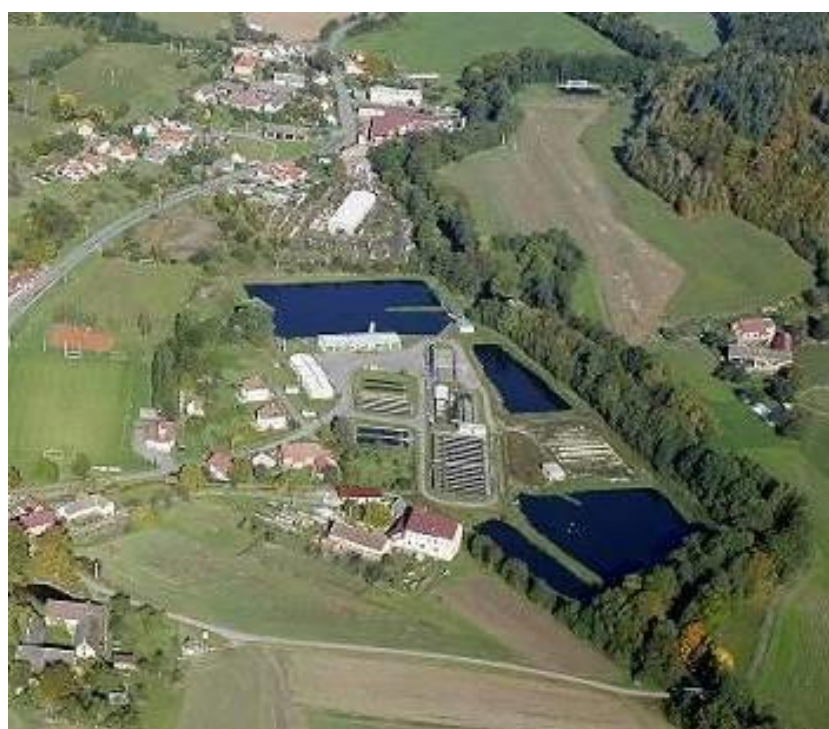
Fig 7. Aerial view of Ujčov with area of fisheries in 2010. Source: Štarha, 2010

Weir itself has undergone extensive renovations in 1940 and took its present image of a concrete object. The mill was used till 1950 with different intensity when its service was stopped. From that time, water in the millrace flew just slowly and the main flow volume flew over the weir uselessly. Grounds on the right bank including the millrace were redeemed before 1978 and large complex of trout breeding has been established there. It used backwater of the weir for inflow. State fishery searched for suitable place for erection the trout breeding and they were able to agree on redeeming of appropriate grounds just in Ujčov. The complex consists of several bigger water tanks (Fig. 7). Water flew between those water tanks through nurseries, in which there were trout in fattening. Water flew from the lower tank back into the Svatka river. During last several years the trout breeding was out of service but these years the service was partly renewed by water inflow from river right into the nurseries (bigger water tanks are not used). Village has changed considerably due to the construction of fishing grounds; also the level of underground water has increased. Flanking vegetation of millrace was removed and possibility to produce electricity from renewable source has decreased due to the development. The complex capacity is oversized and there has been unnecessarily large land grab. On the other side delay a relatively large amount of water in aquaculture is certainly positive.

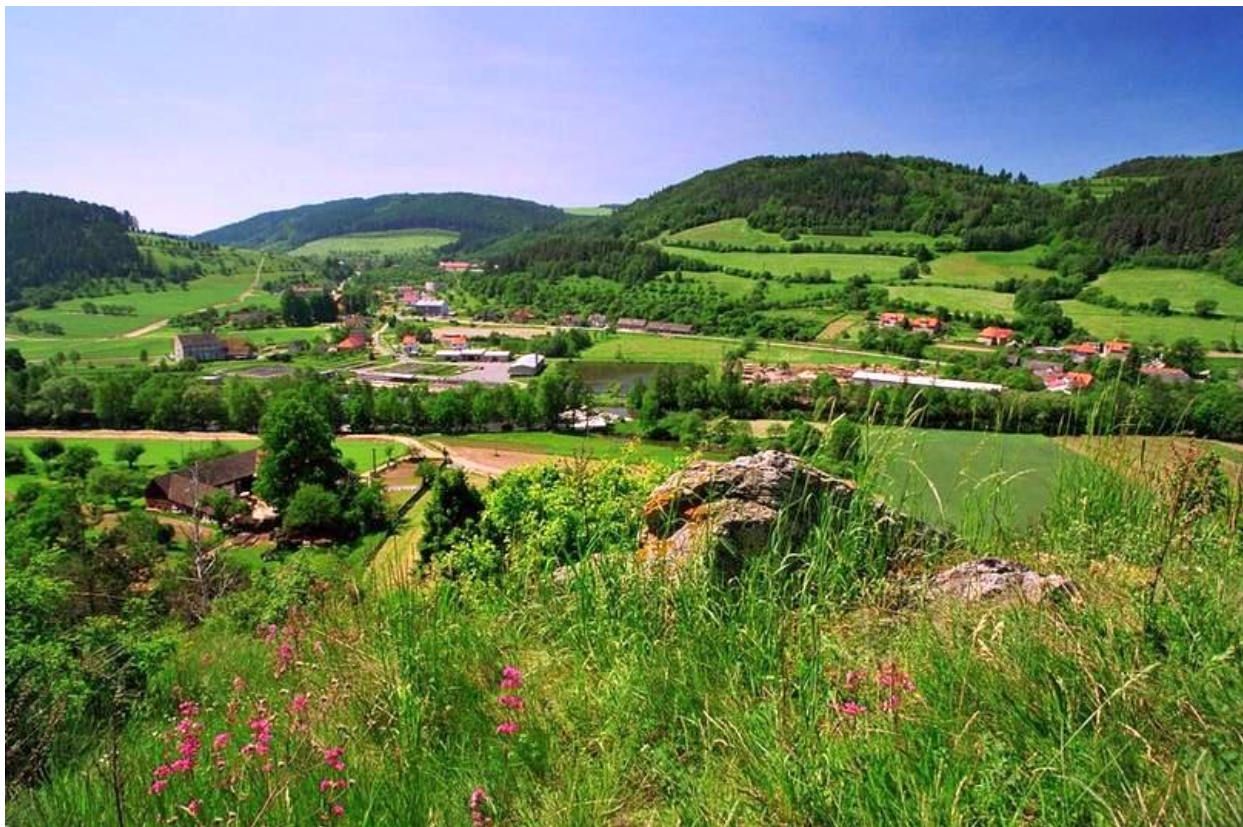
Fig 8. View on the locality form Burša hill (2000). Source: <http://info.bystricenp.cz/ujcov>

Solid concrete weir with wooden supers, which ensures the inflow of water into the fish hatcheries located on the right bank of Svatka river is a prominent feature on the flow in

the area of interest. Backwater of the weir is evident to row. 94.300 km. The longitudinal slope of the weir trough increases and hence the rate of water which slows down until the first sharp meander.

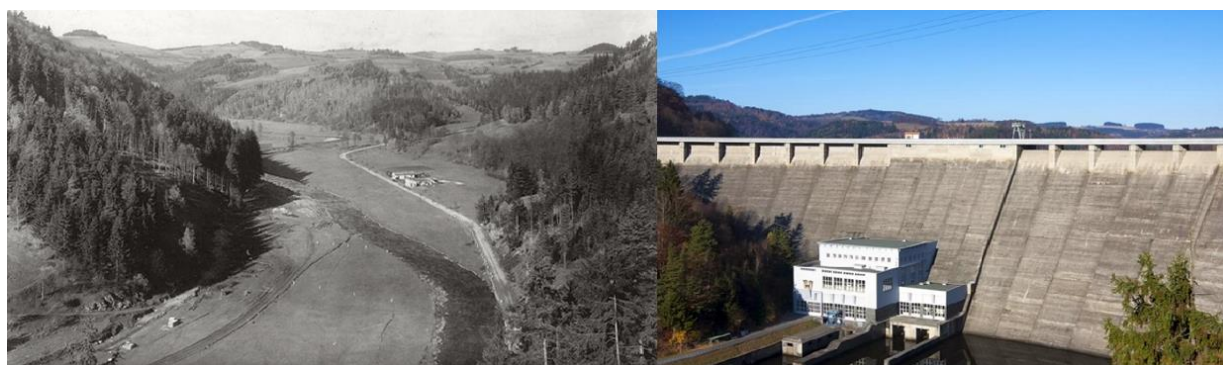
Fig 9. Vír dam (the place of the dam before construction (1953 and nowadays). Source: <http://www.virvudolisvratky.cz>

The storage plant Vír (Fig. 9) built on Svatka river ca. 10 km far from site of interest strongly influenced conditions in the stream below the dam, and even the landscape and land use. The issue of Vír dam is not part of this work, but it is necessary to mention its impact on the landscape in the basin underneath the tank, which was crucial.

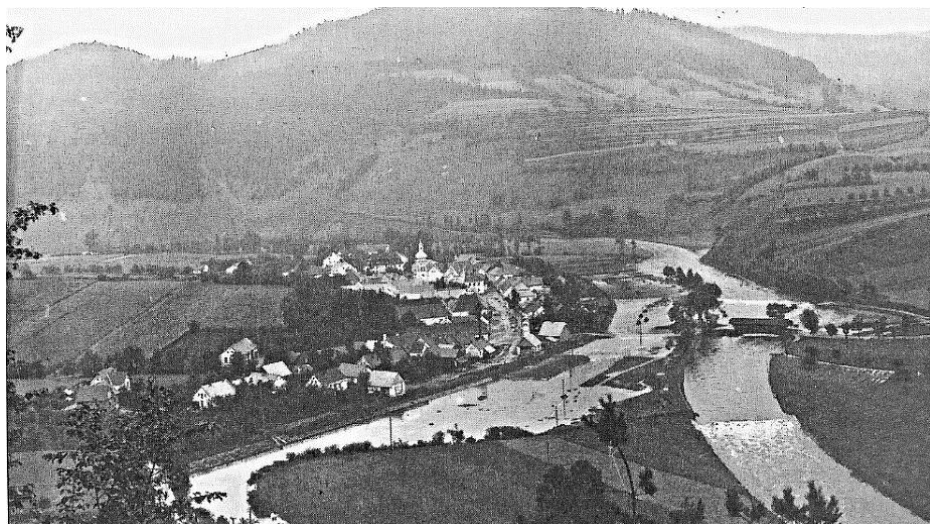
Fig 11. Svratka River during the flood in neighbouring Štěpánov n. S. created new river bed around 1922. Source: Jurman, 2014

Floods occurred during spring seasons by snowmelting and ice running with following ice barriers in the river bed were more frequent before constructing of the dam. Next floods were caused in summer time by torrential rainfall with a longer duration of critical rain (Fig. 11).

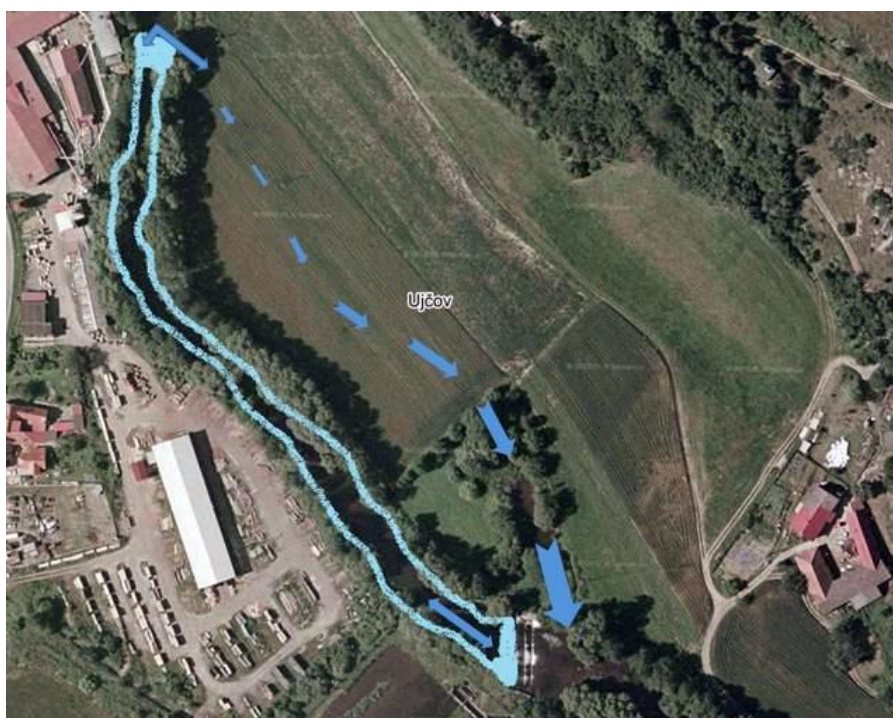
Fig 12. Schema the oxbow creation (underlay aerial map Mapy.cz 2006, modified by author).

Water overflow from the river bed above the weir even at low flow rates thanks to ice running and ice barriers. The water that poured out on the left bank near the bend in the weir gradually formed centred drain in the lowest areas. As a result of increasing speed of the water flow water erosion has started and creates a new channel, which flowed back into the Svratka weir (Fig. 12). This development had again a significant impact on changing the landscape in the area of interest, while part of the oxbow is still preserved. The greater part of Svratka oxbow was gradually filled up and cultivated into farmland again.

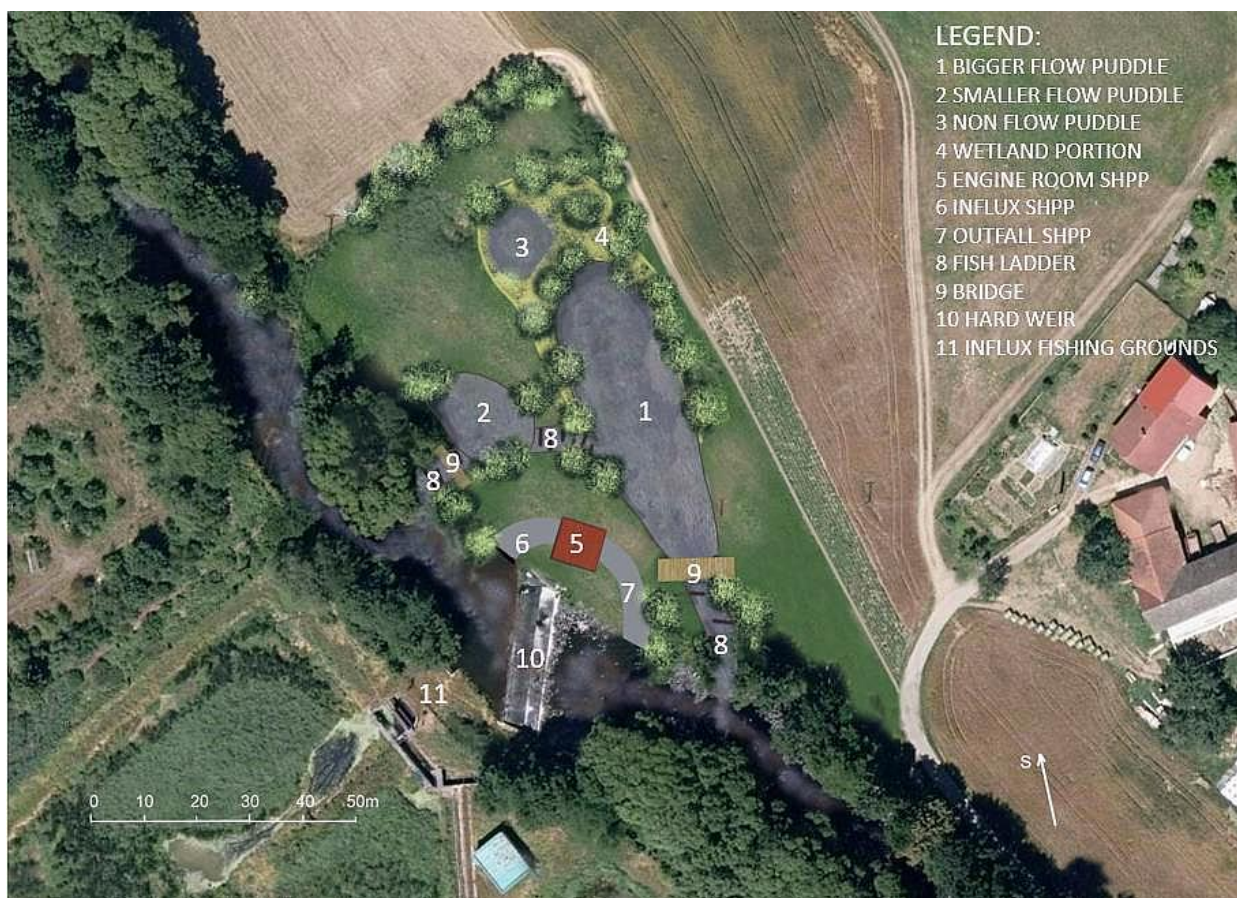
Fig 15. A schema of possible visualization of modification of left bank land (created by authors).

Assuming the construction of small hydropower plant is needed to build a fish pass at the same time ensuring fish migration. In this case, left bank land can be used, which is also privately owned by investor, and pools to establish a fish ladder and the creation a nature friendly measure for fish migration. The surrounding area consists mainly of permanent grassland and suitable natural vegetation. Fallow land will be positively utilized due to binding of a fish ladder at the pools (Fig. 15).

The first flow pool follows the position of the current pool. It is appropriate to provide a gentle slope inclination when building ponds, mainly due to the stability of banks, development and vertical zonation of coast zone. Such shores are not necessary to fortify separately. The problem of land-filling can appears mainly in pools of small dimensions follow a few feet

The second smaller flow pool constructed between the original one and Svratka river bed will be partly used as a sedimentation tank. Due to its oval shape and dimensions of about 5 x 15 m there will be no problem with periodic extraction of sediments.
